Natural Water Quality
in Butano Formation Wells

2004 Groundwater Management Annual Report
Scotts Valley Water District
April 2005

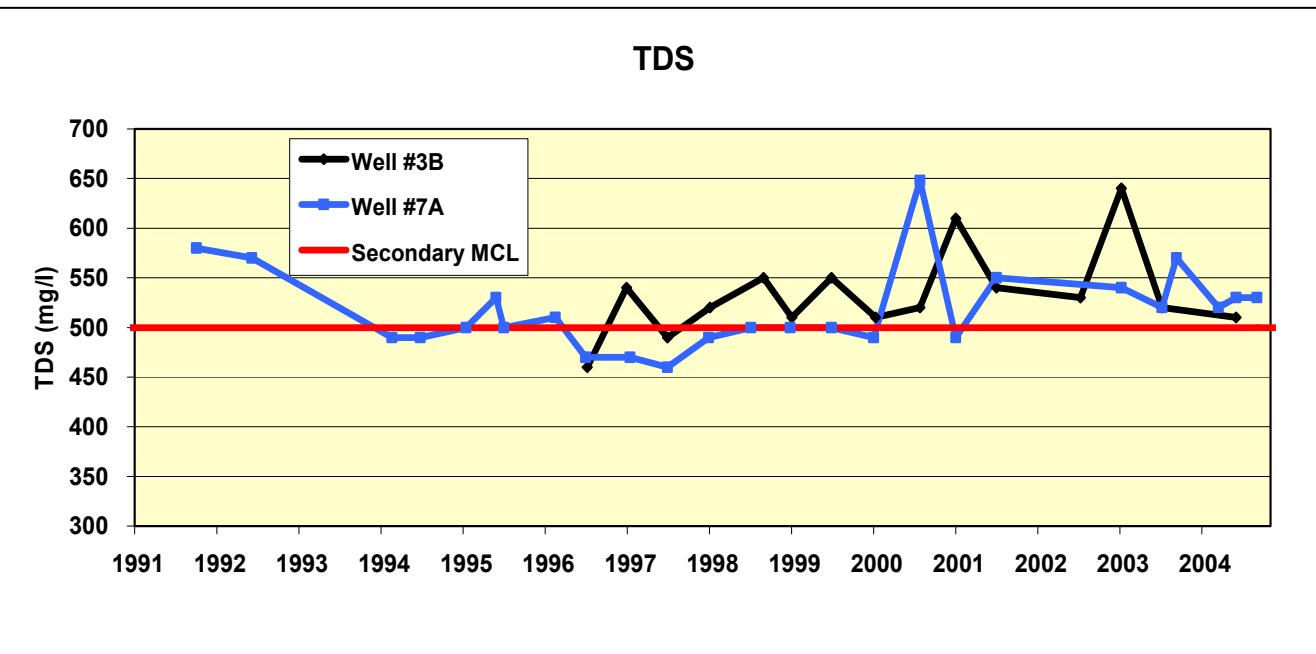
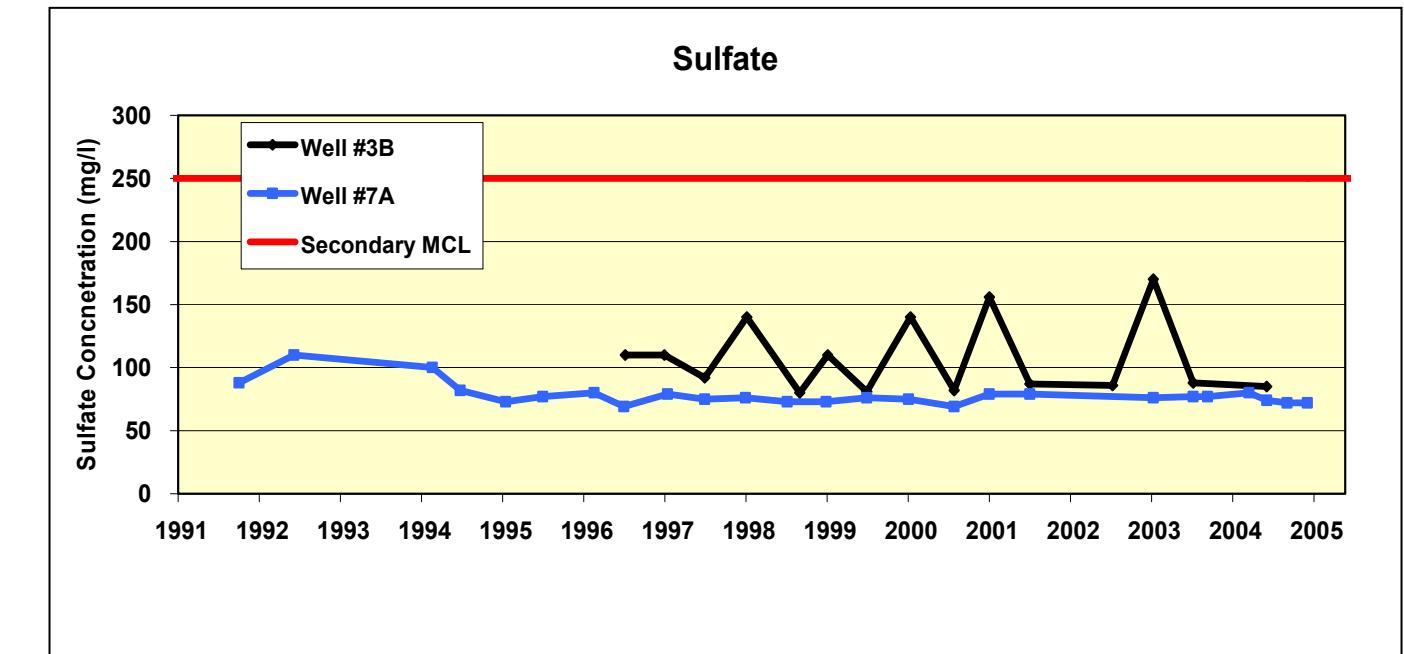
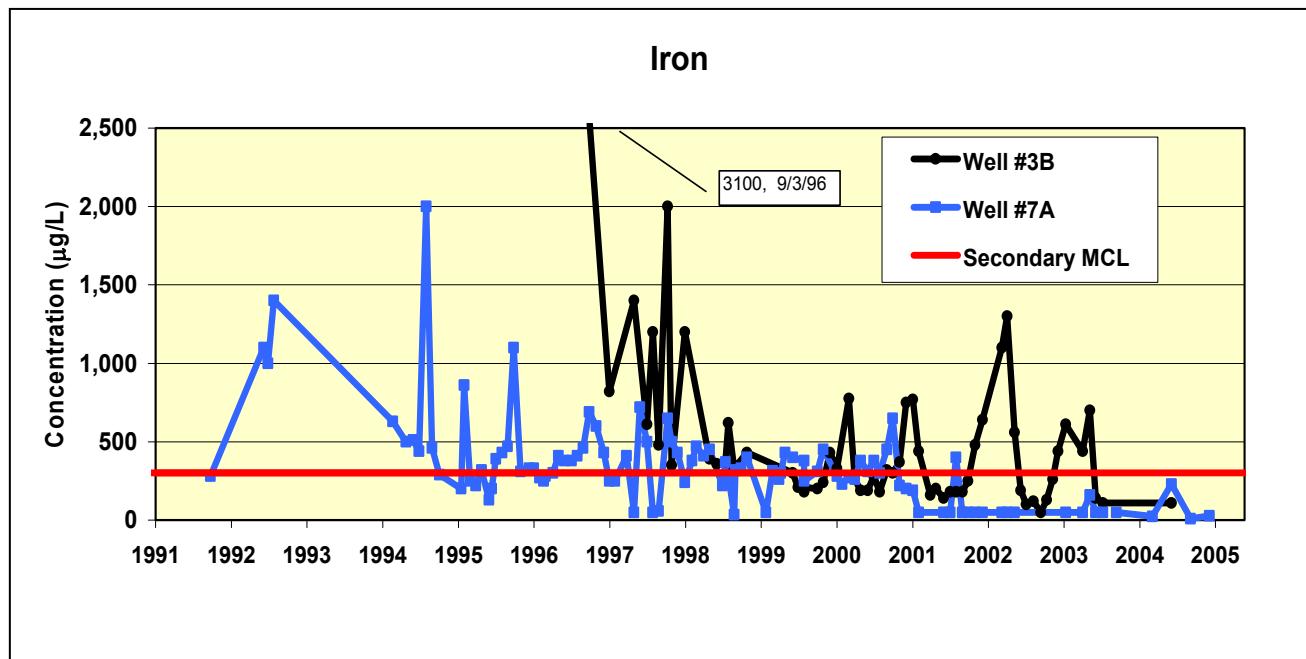
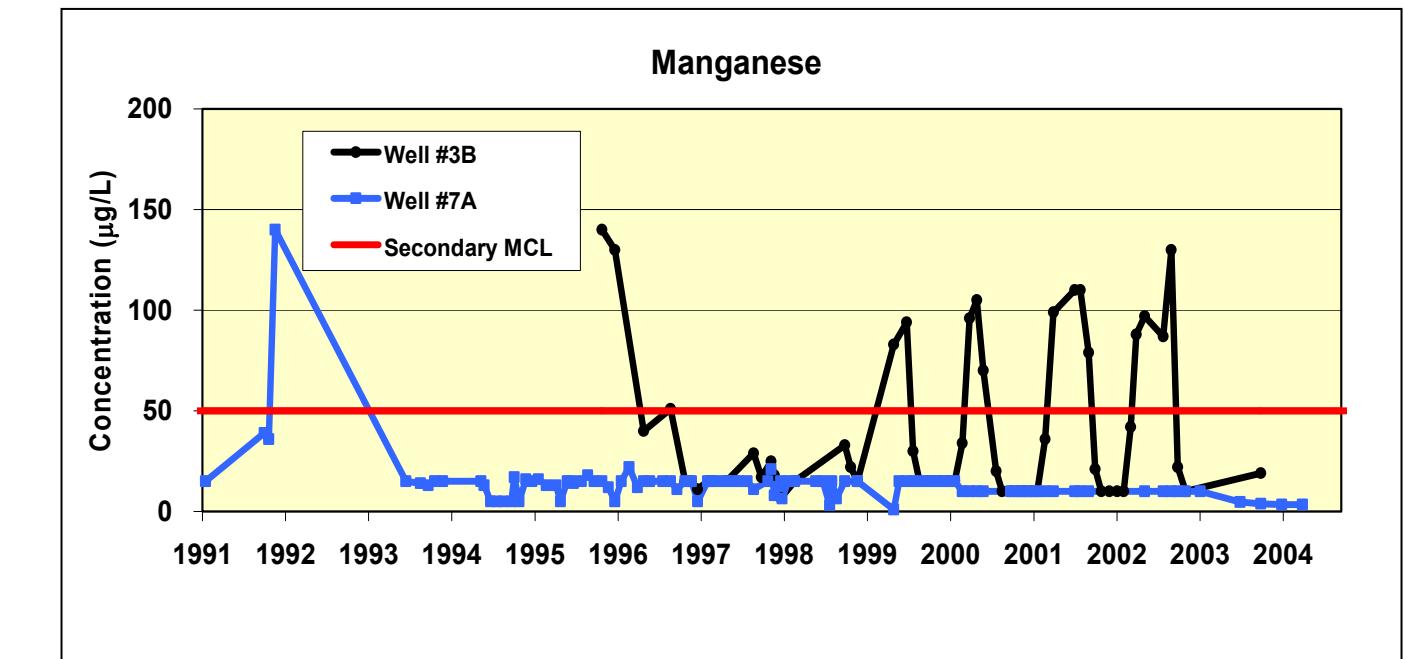
FIGURE
6-1

Note: Arsenic and Nitrate have not been detected in wells extracting from the Butano Formation. Secondary MCL represents the regulatory limit established by the California DHS to reflect undesirable aesthetic water quality.

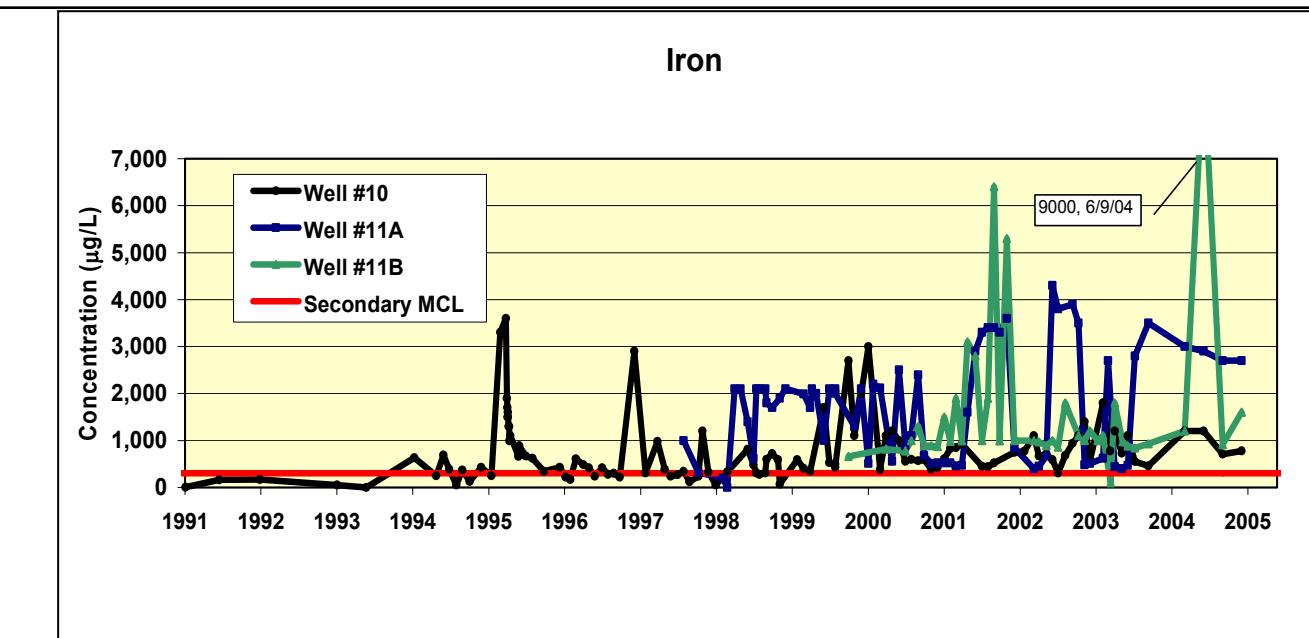
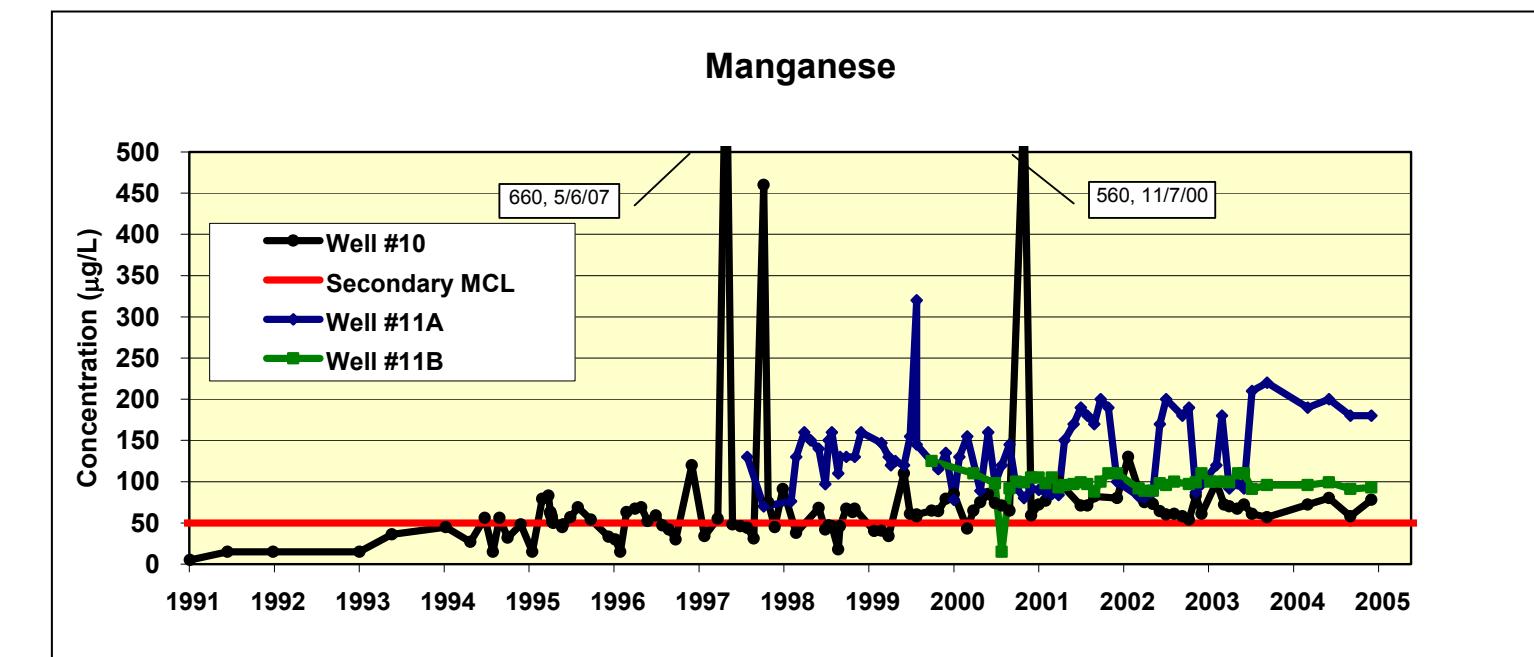
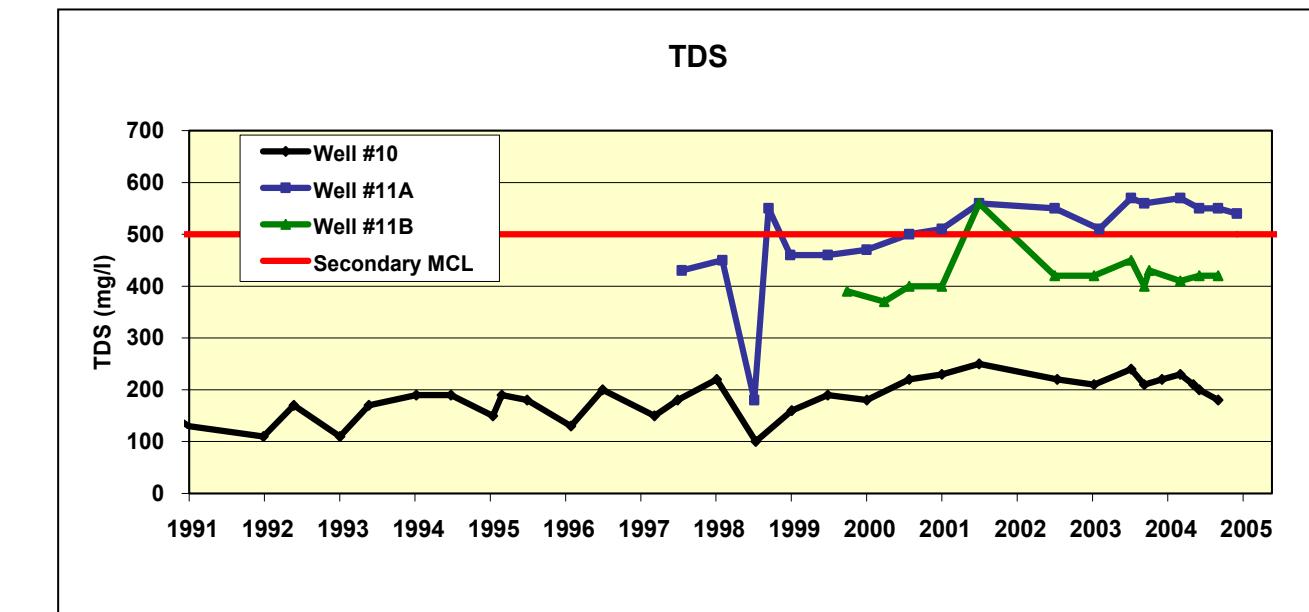
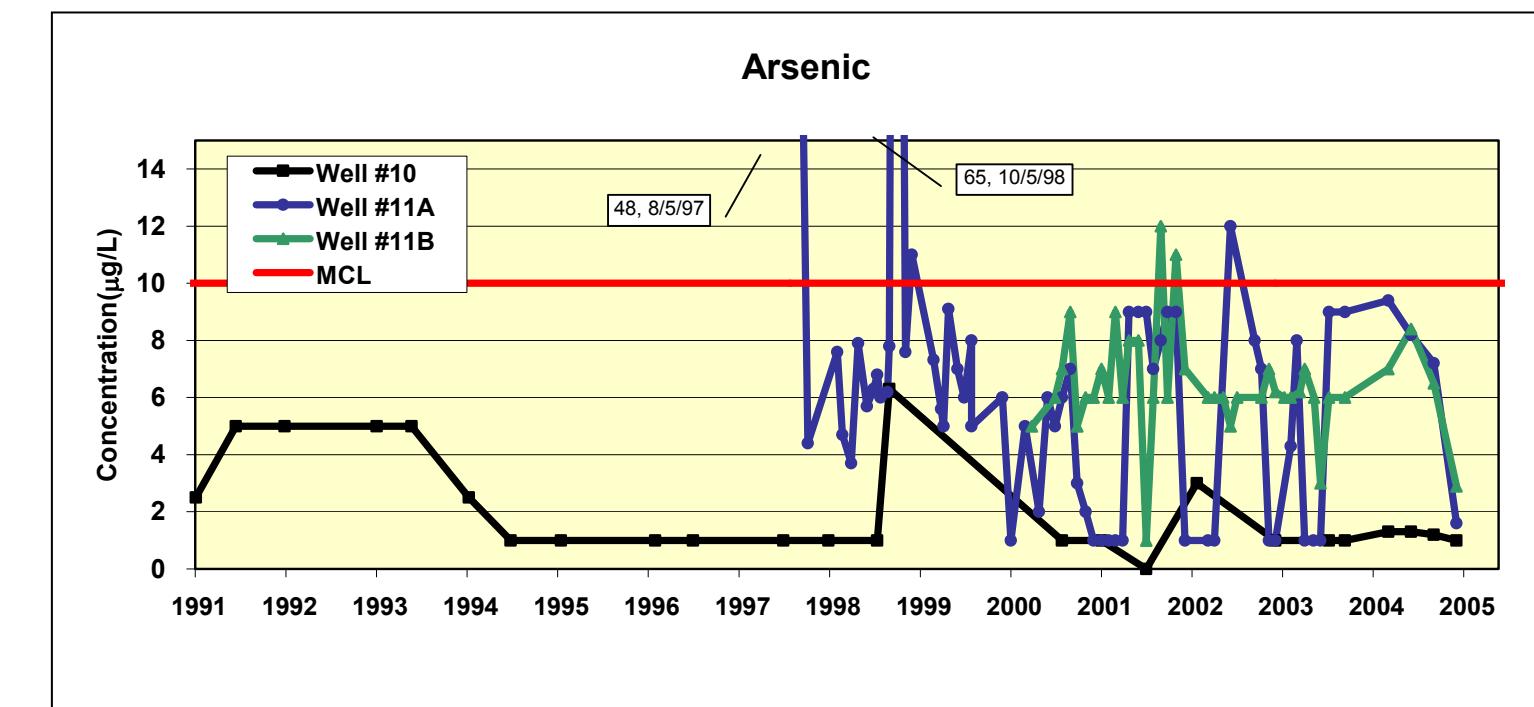
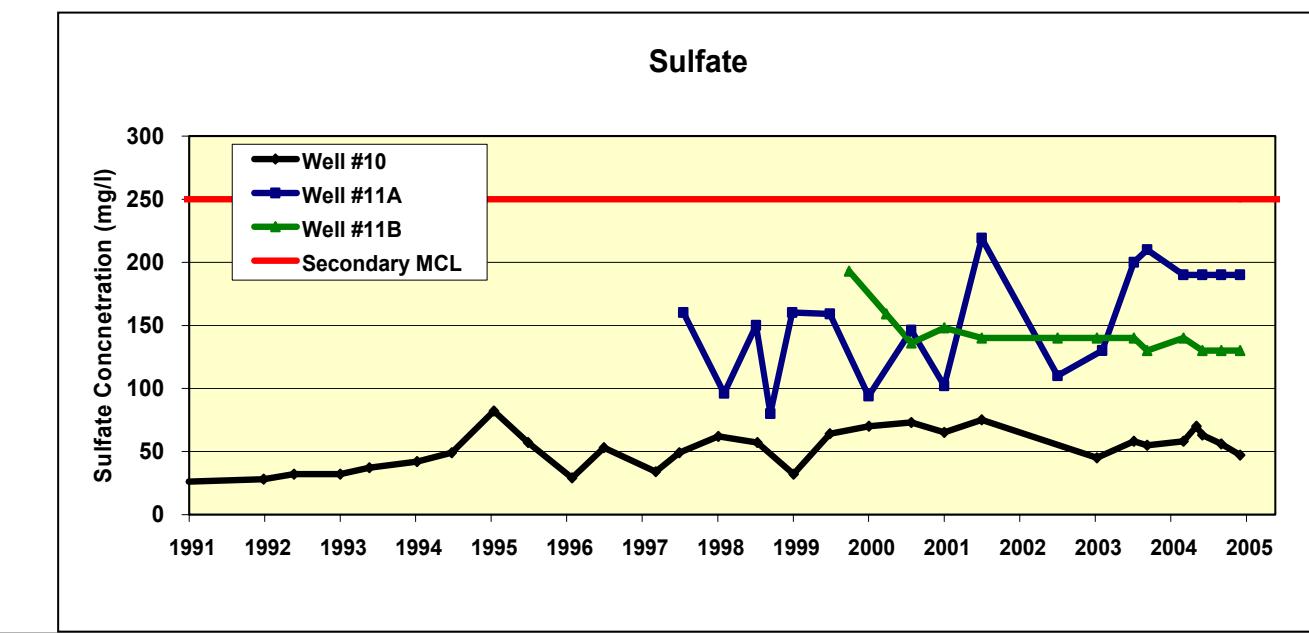
Note: Nitrate has not been detected in wells extracting from the Lompico Formation. Secondary MCL represents the regulatory limit established by the California DHS to reflect undesirable aesthetic water quality.

Natural Water Quality in Lompico Sandstone Wells		
2004 Groundwater Management Annual Report Scotts Valley Water District April 2005		
ETIC ENGINEERING	FIGURE 6-2	Filename:

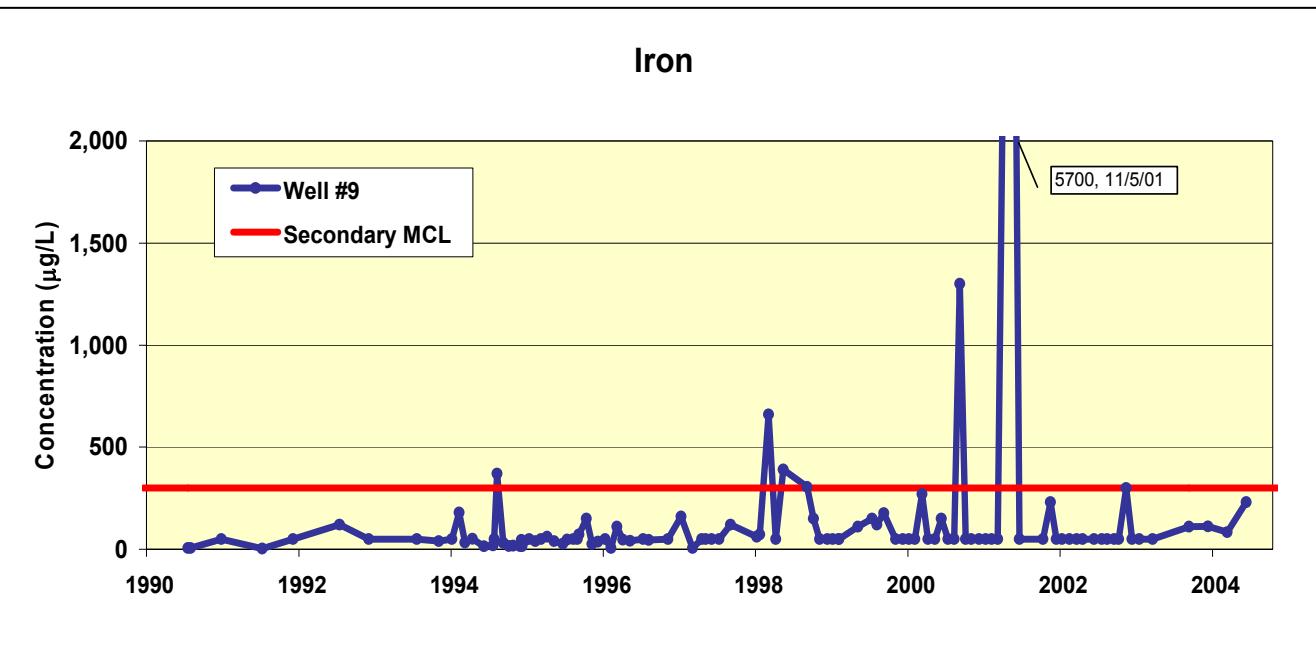
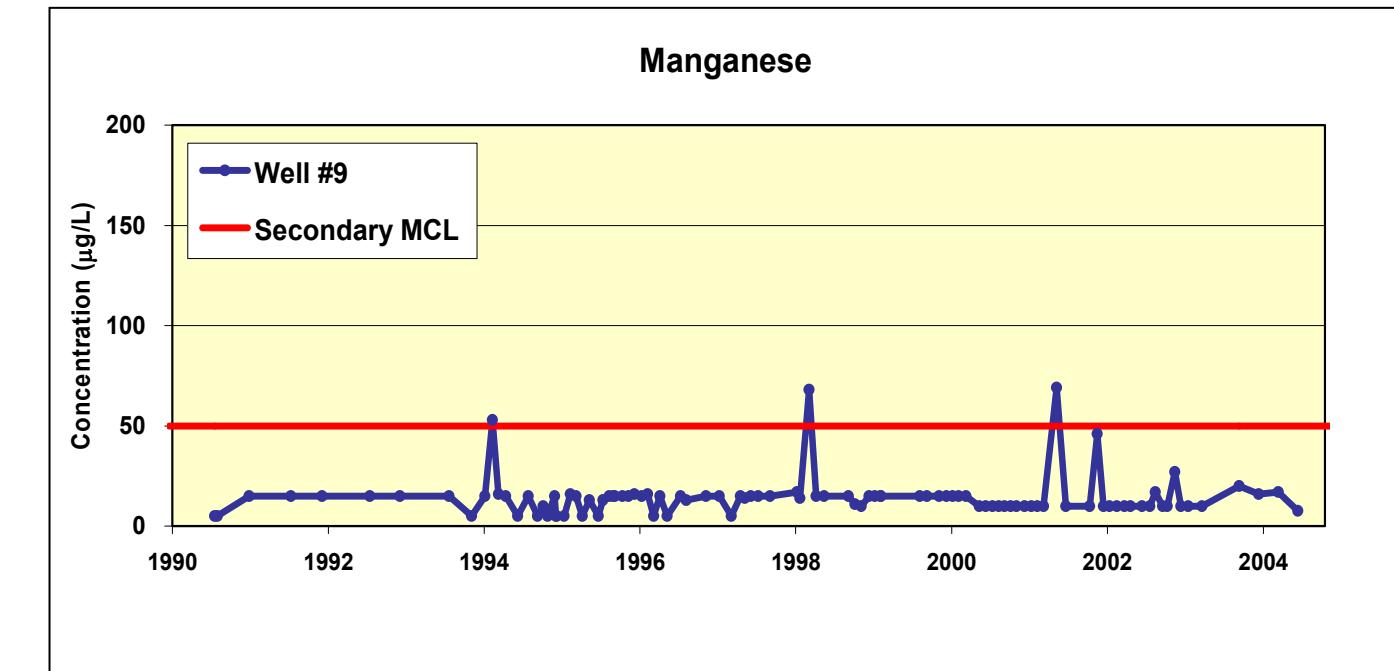
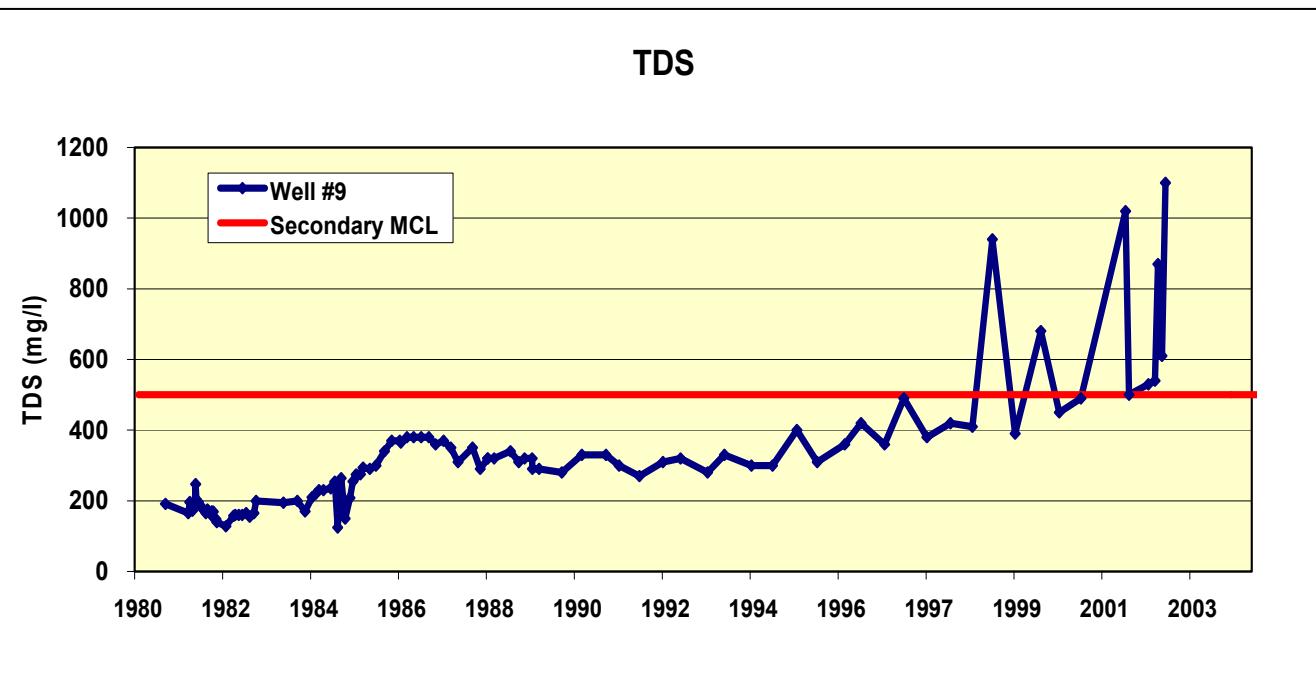
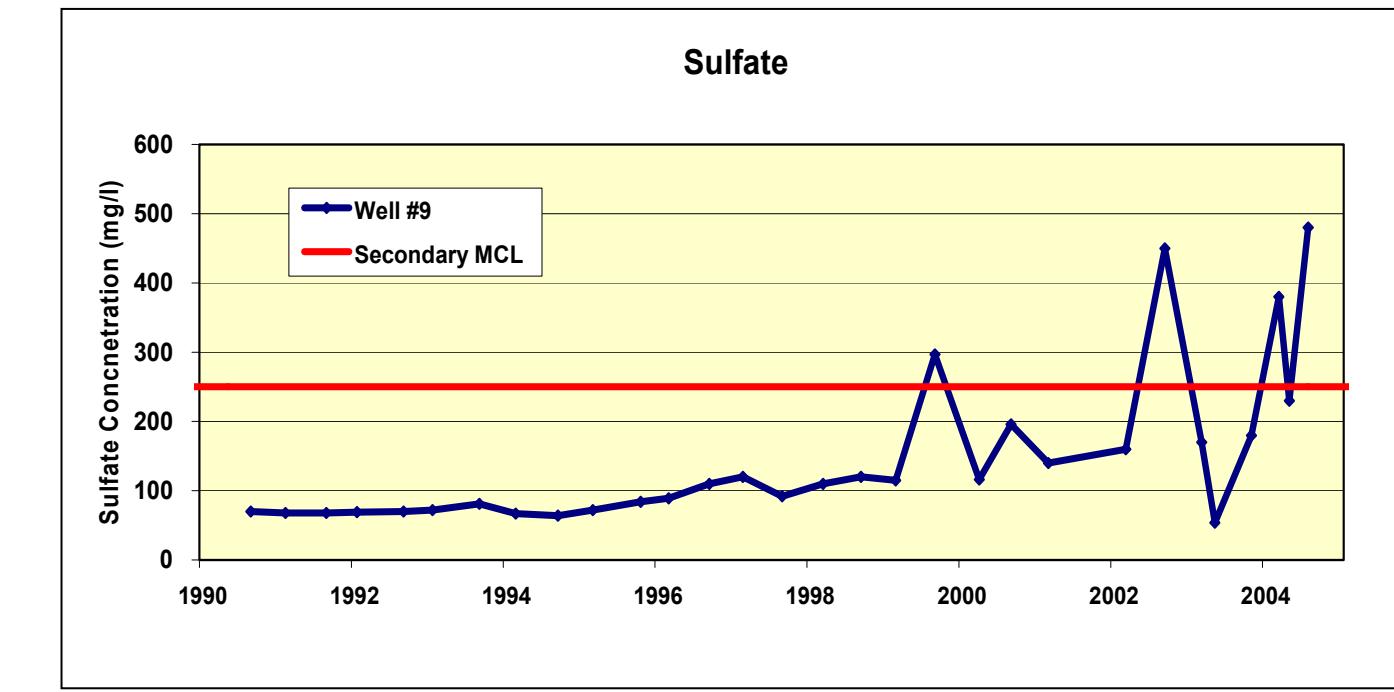
FIGURE
6-3

Note: Arsenic and Nitrate have not been detected in SVWD production well #9. Secondary MCL represents the regulatory limit established by the California DHS to reflect undesirable aesthetic water quality.

Natural Water Quality
in Santa Margarita Sandstone
and Monterey Formation Wells

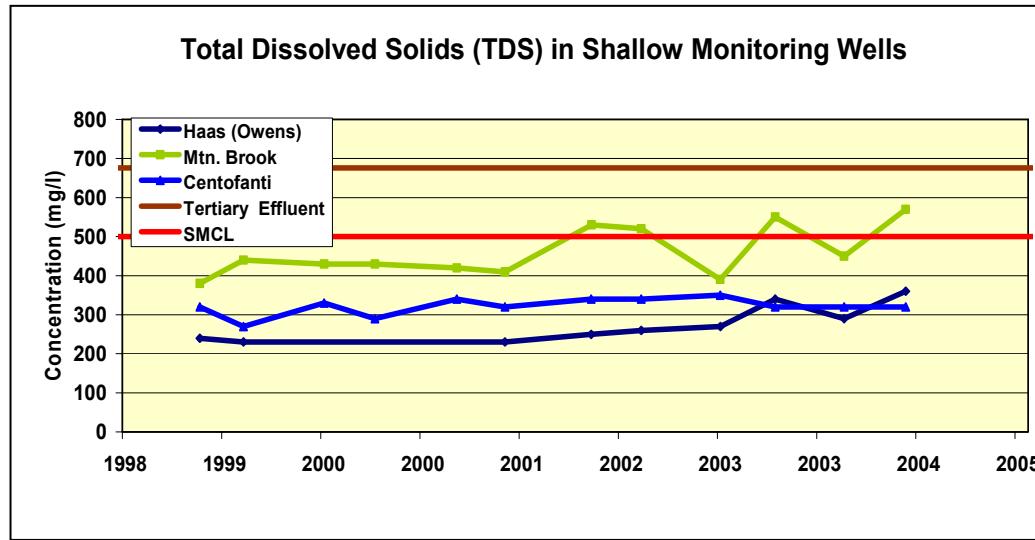
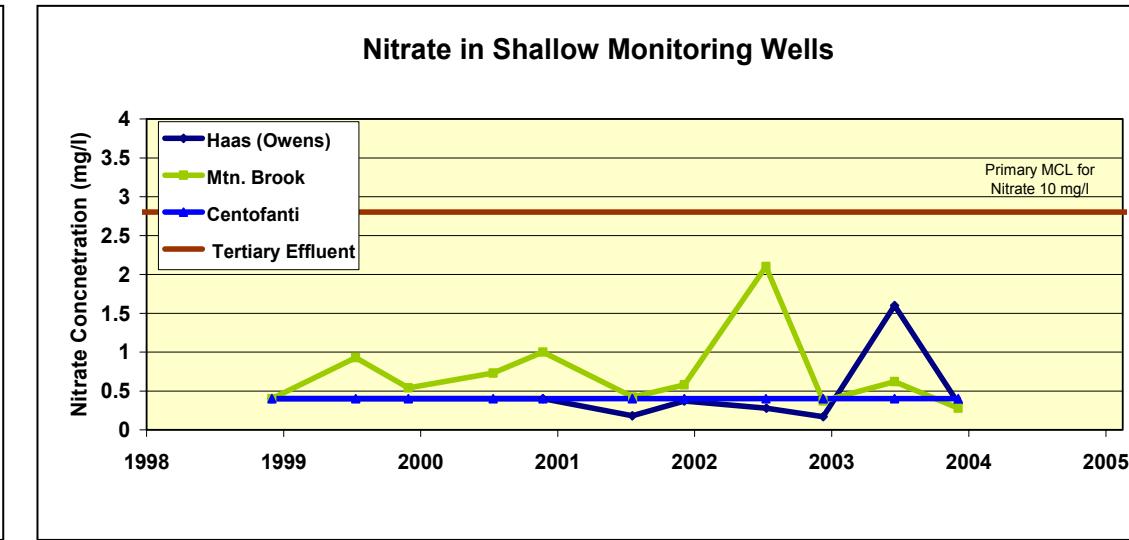
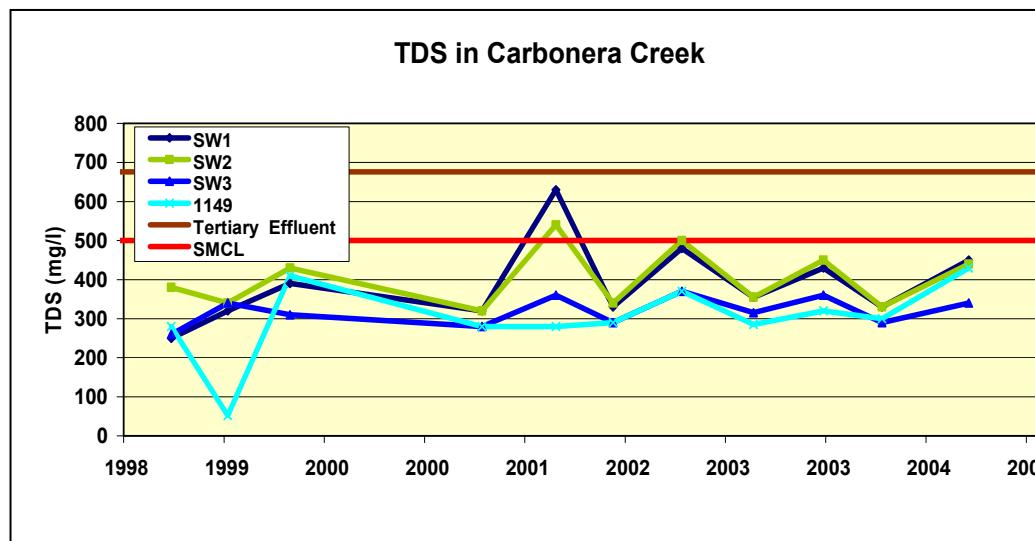
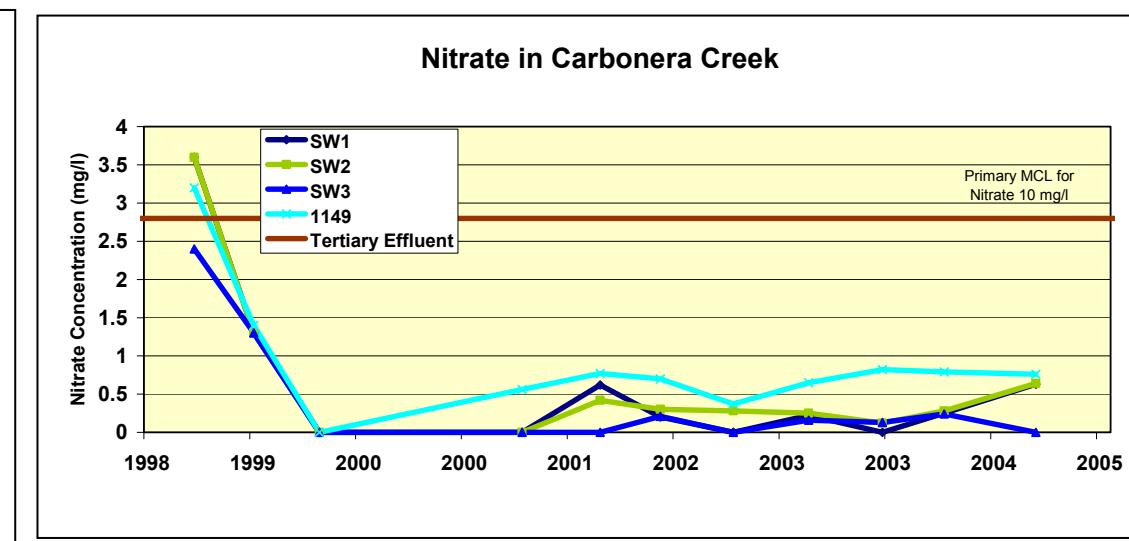
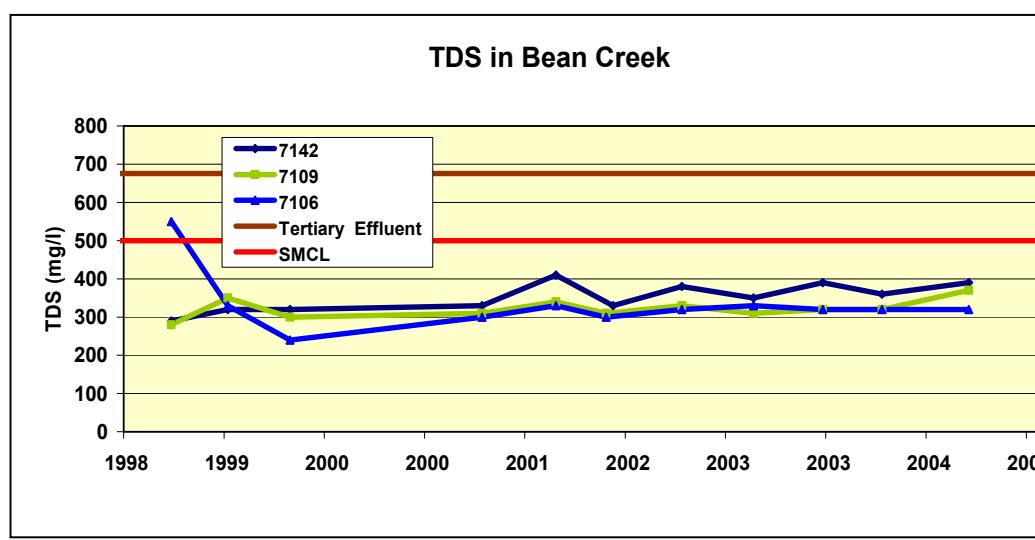
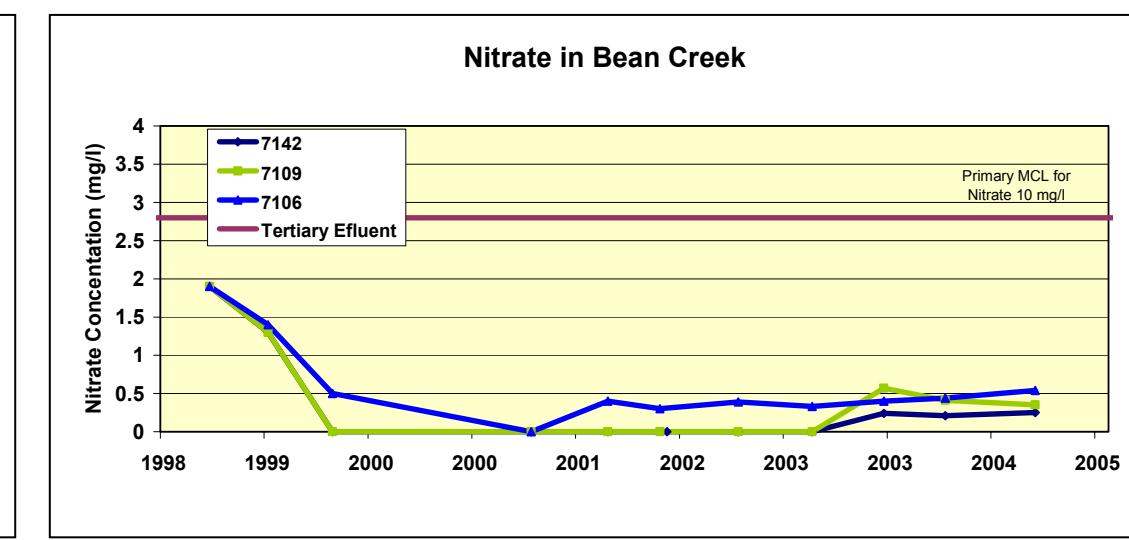
1. Primary MCL for Nitrate measured as Nitrogen is 10 mg/l.
2. Other water quality parameters not shown are listed in Appendix E.
3. TDS measured in SVWD production wells shown in Appendix E
4. Tertiary Effluent represents the average concentration of TDS and Nitrate in recycled water as it is discharged from the Scotts Valley WWTP
5. Secondary MCL represents the regulatory limit established by the California DHS to reflect undesirable aesthetic water quality.

Recycled Water Monitoring Program:
TDS and Nitrate in Shallow Wells and Surface Water

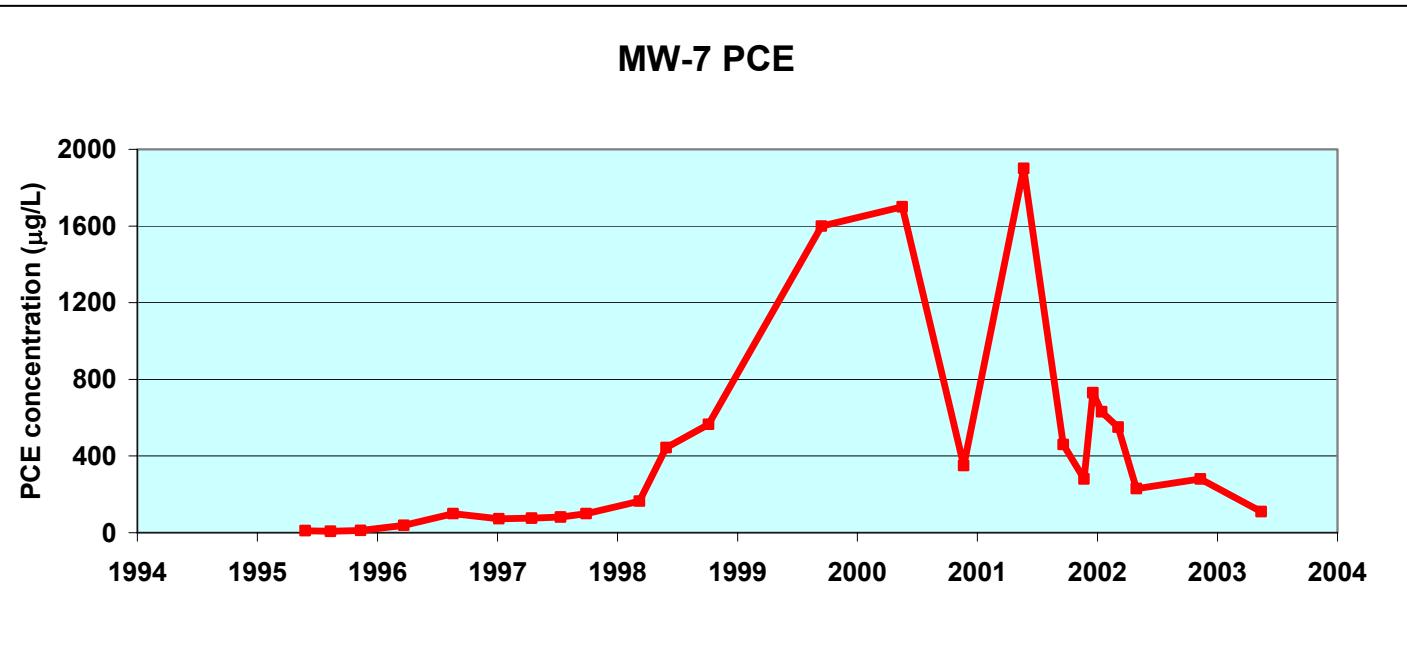
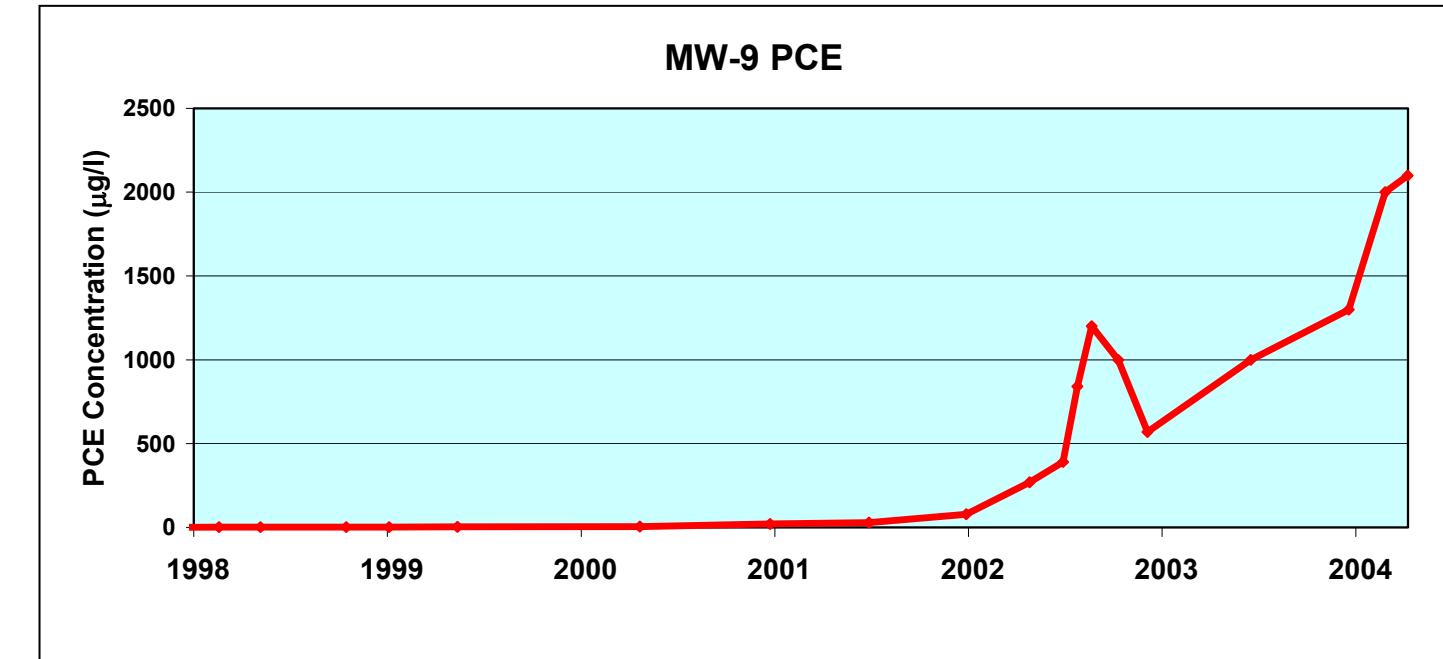
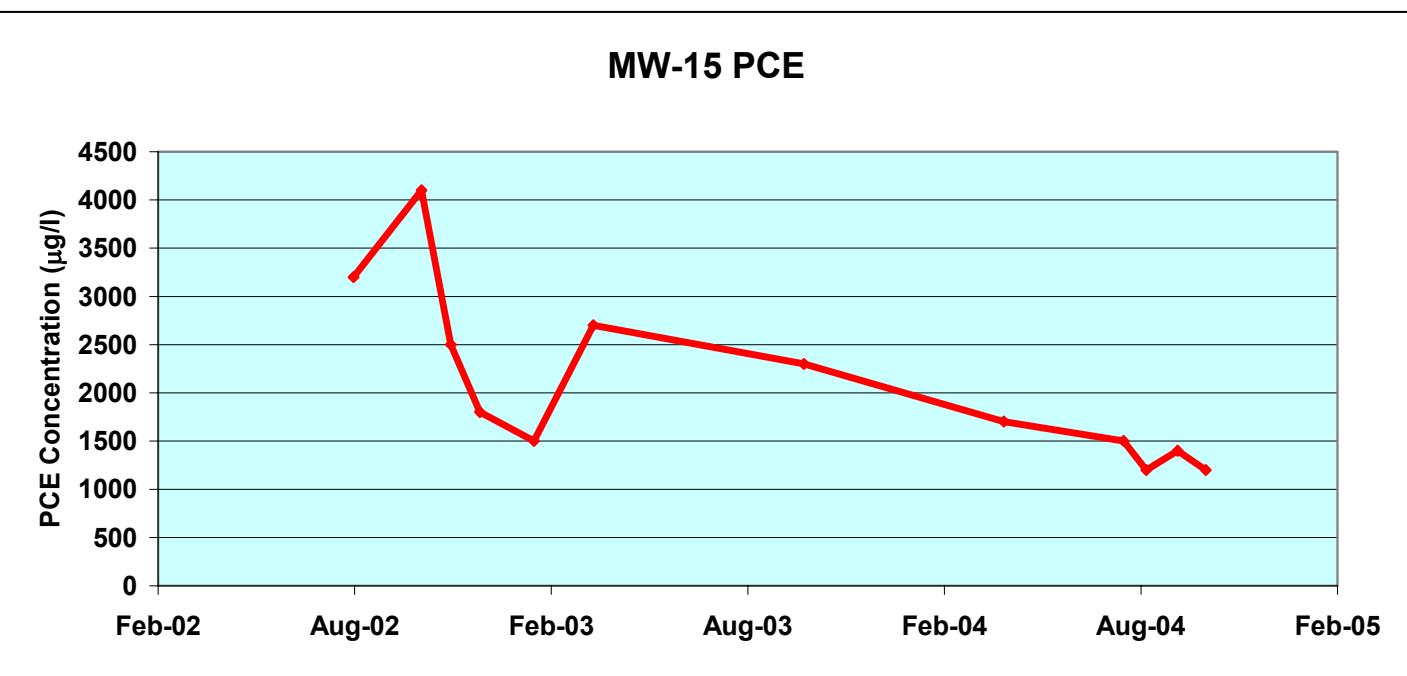
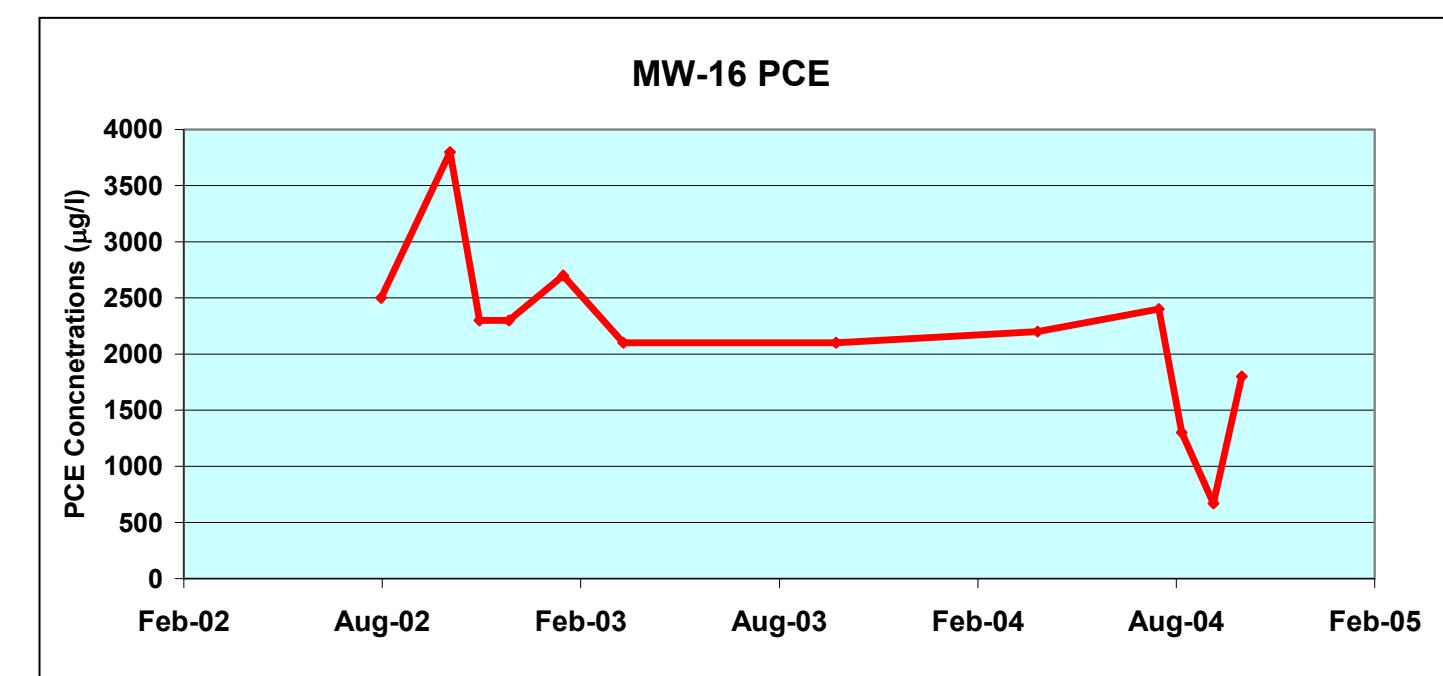
Note: Significant variation in concentration scale. PCE concentrations shown for 4 of 14 monitoring wells on site.

Environmental Compliance Summary:
Scotts Valley Dry Cleaner, PCE Trends

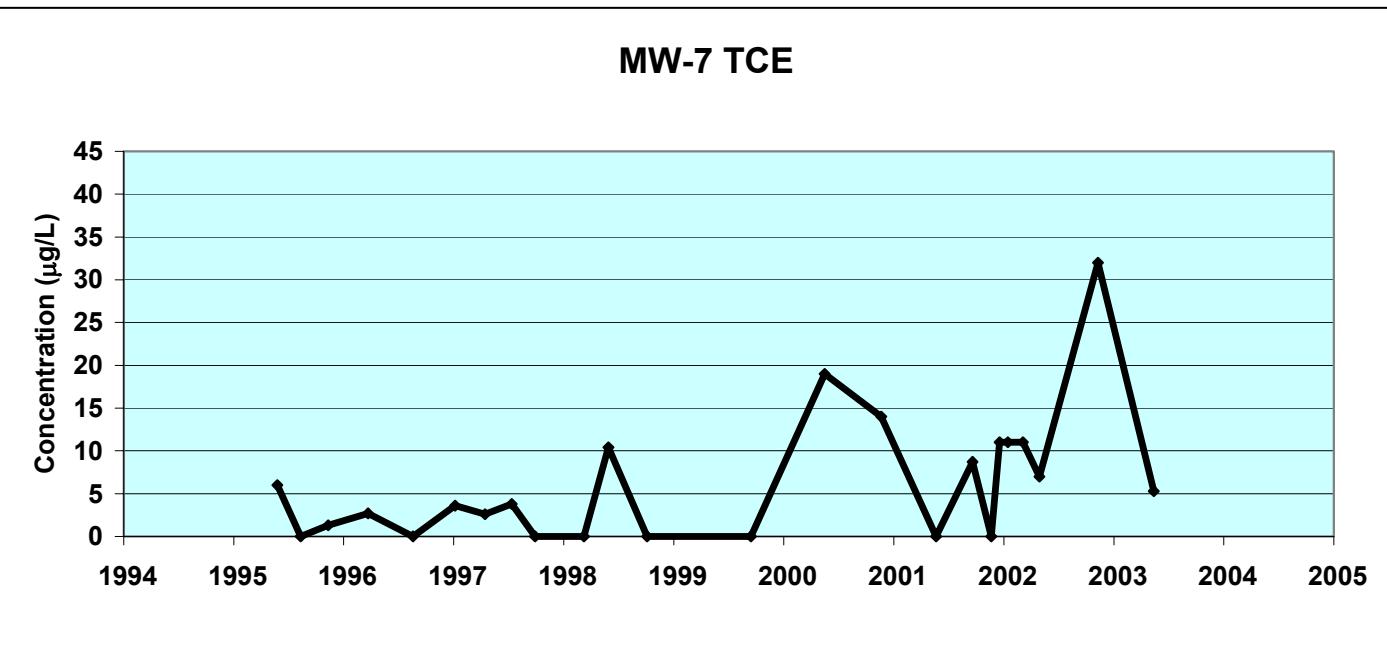
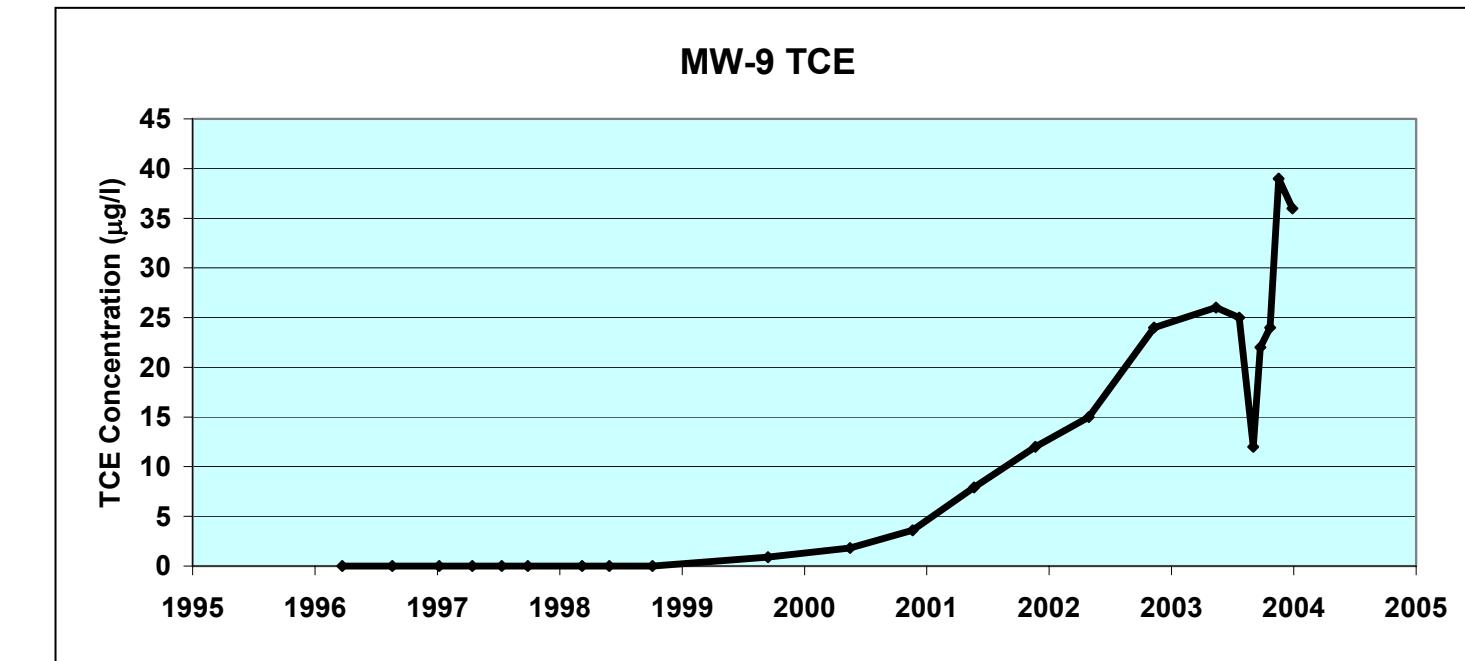
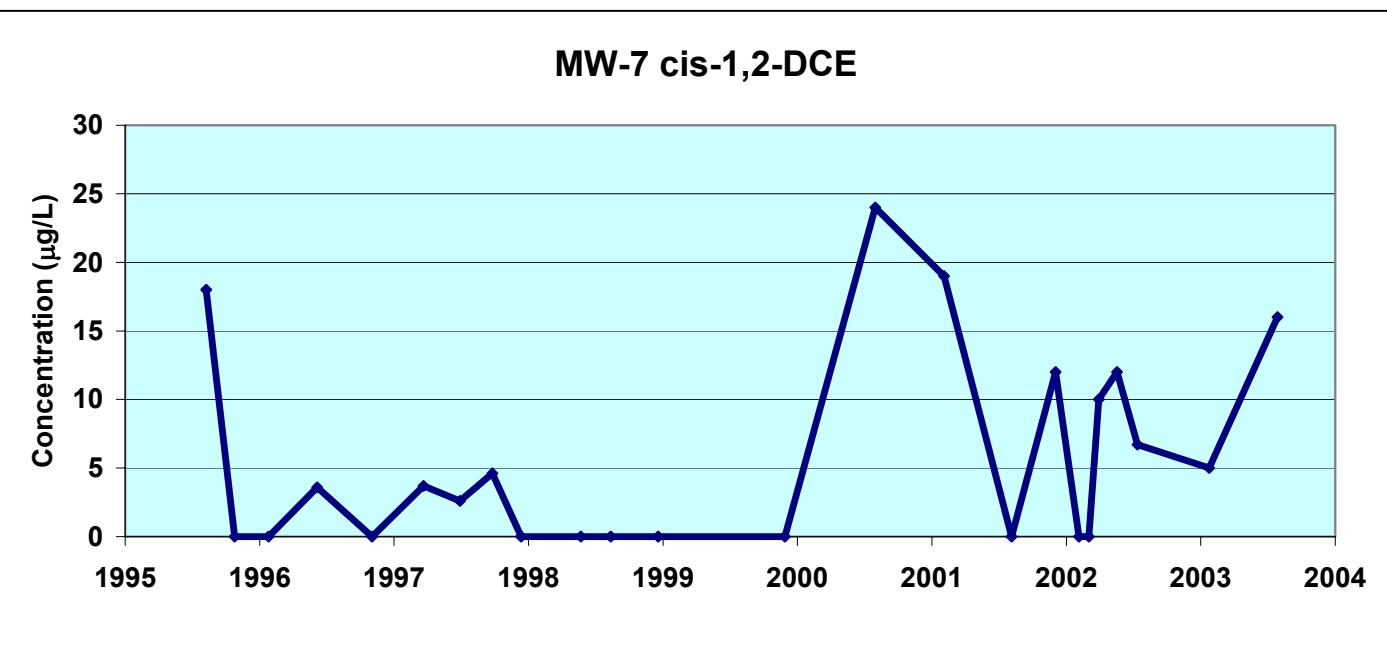
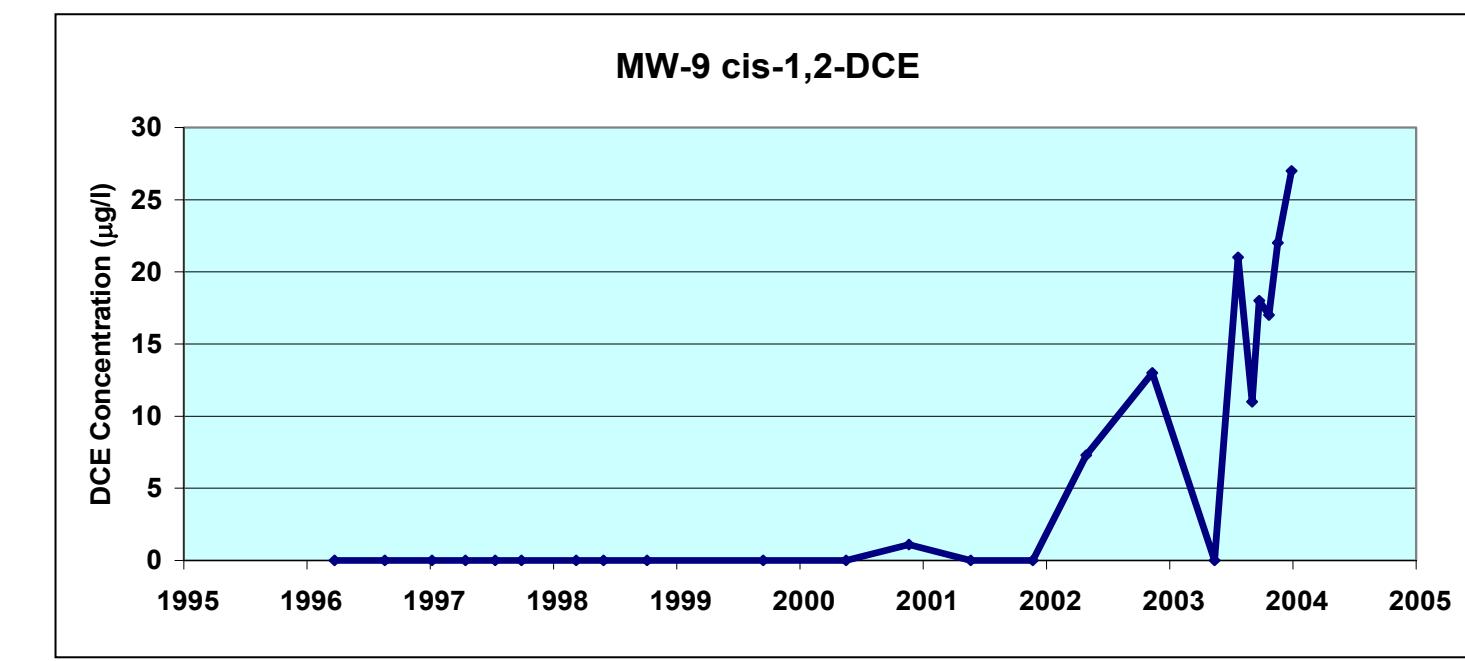
Environmental Compliance Summary:
Scotts Valley Dry Cleaner, TCE/DCE Trends
